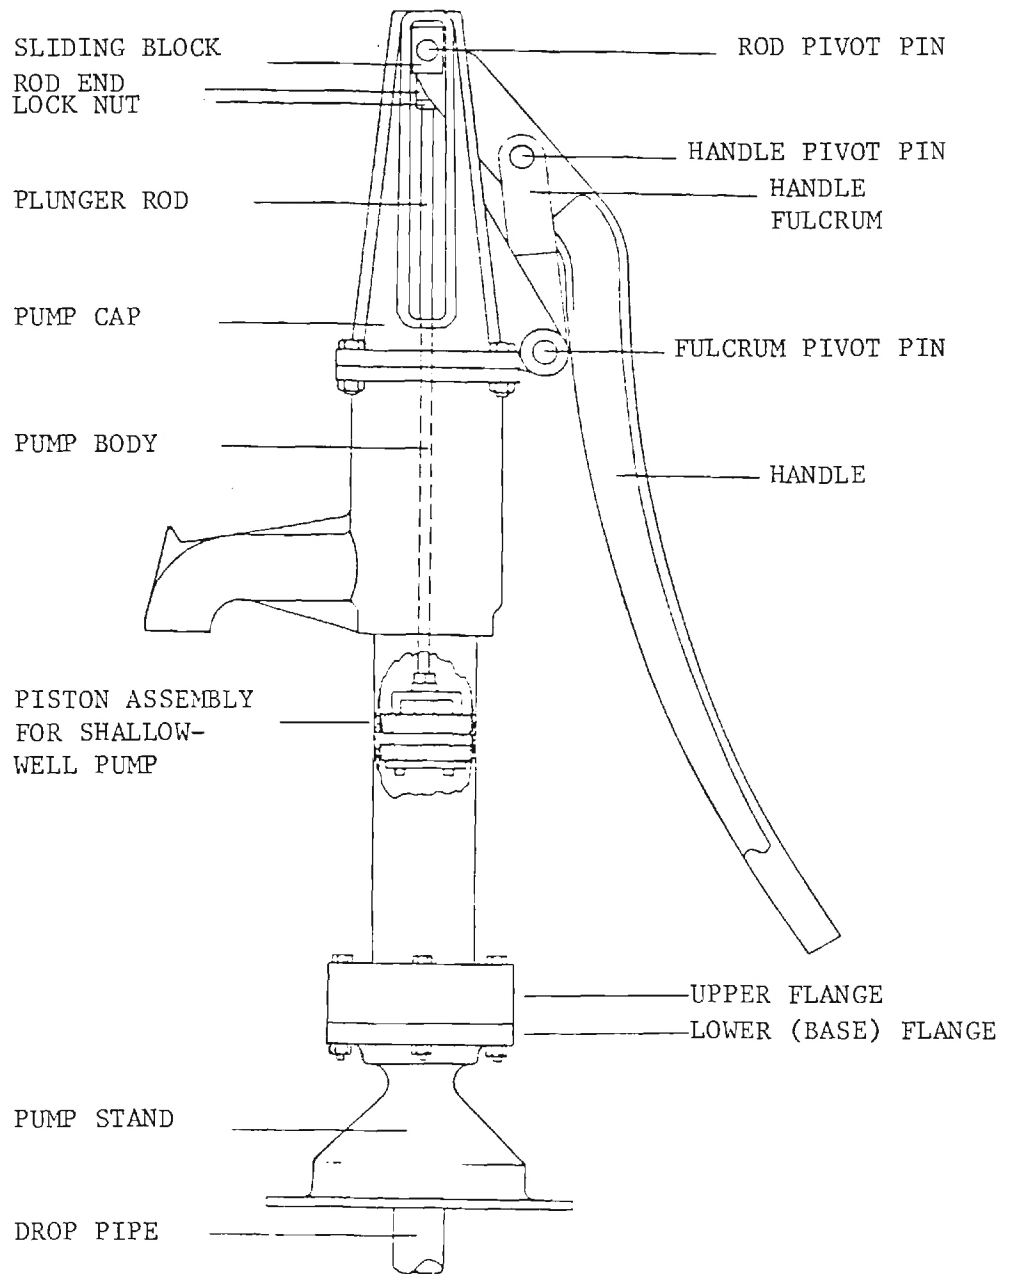
Figure 3.

Somasiri Huller Manufactory has made a slight modification to the pump base by adding a flange that is bolted to a second (upper) flange which has the pump's three-inch galvanized iron pipe screwed into it. Thus, the factory can secure the pipe to the upper flange very tightly and, with the use of a joint compound, lessen potential loosening of the pipe from the base when the pump is operating in the field. When the shallow-well pump's foot valve is to be changed, the upper flange is unbolted from the base flange rather than breaking the factory seal between the pipe and the pump base. This modification, shown in Figure 3, deserves further consideration by AID/Washington.

2. With the exception of a modification to the pump base, the manufacturer, Somasiri Huller Manufactory, is still producing the AID hand pump according to specifications with proper quality inspections and the use of jigs and fixtures for interchangeability of spare parts. The advantage of this modification is that the pipe section of the pump body can be screwed into a threaded flange, sealed with pipe compound and/or Teflon tape, and then bolted to the base which also has a flange cast at its top to prevent loosening and resulting leakage of water that sometimes occurs where the galvanized iron pipe now screws into the base. The disadvantage of this modification is that a gasket is required where the base bolts to the top flange and it probably will have to be replaced anytime the pump base is unbolted from the rest of the pump (for instance, when the foot valve is replaced or repaired in the shallow-well pump). The Somasiri Huller Manufactory modification, overall, has been well thought-out and should be considered for adaptation on all AID hand pumps.

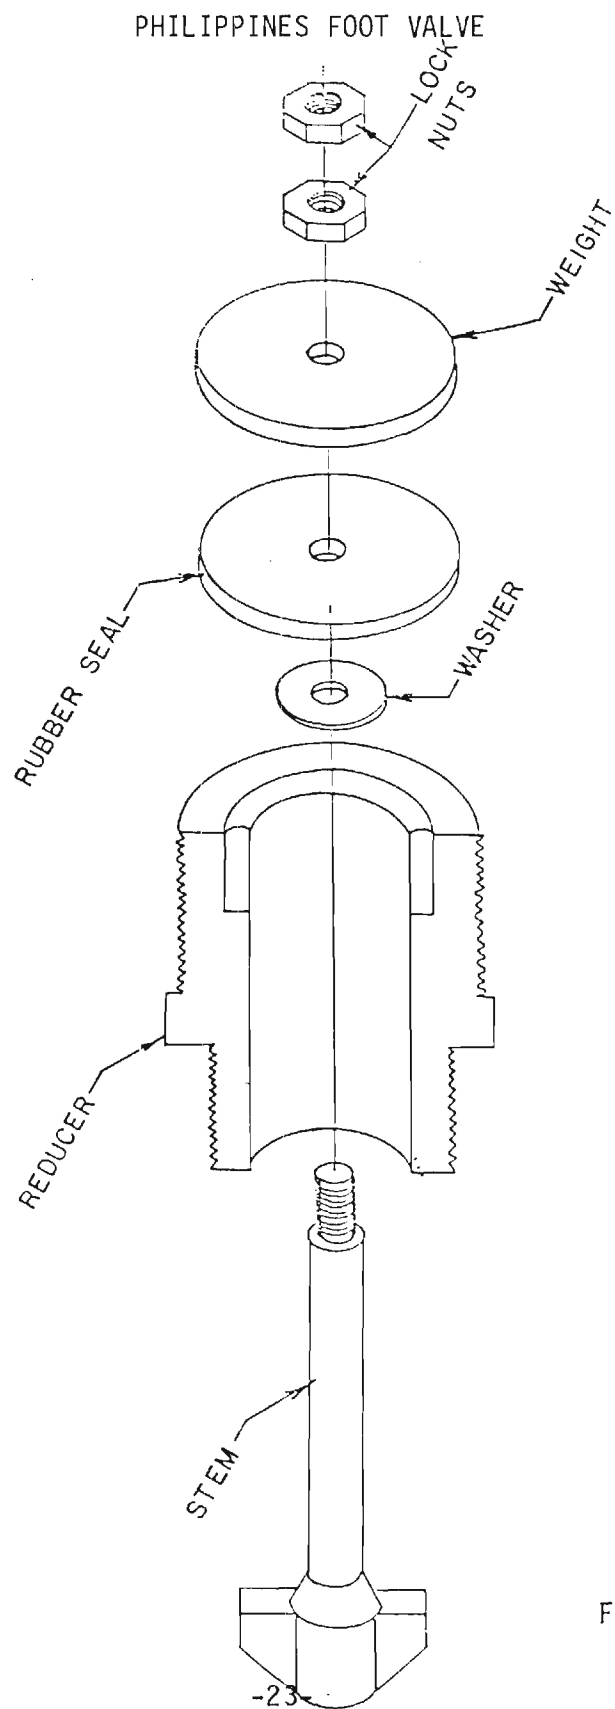
Figure 5.

reliable even when used under extreme conditions. The concept of hardened pins and bushings is valid. Villagers have received and accepted the AID hand pump. The foot valve, while inexpensive and easy to change, seems to be the weak point in the pump design.

Of much greater concern is the short life of the flapper valve used with the AID hand pump. It is highly recommended that a foot valve design (see Figure 5) used with the AID hand pump manufactured in the Philippines or one of equal (or greater) durability be used on all AID hand pumps. The Philippine foot valve has shown very good results in laboratory tests at Georgia Tech, and reports from the field show similar results.
